**MERRIMACK RIVER BASIN
AMESBURY, MASSACHUSETTS**

**BAILEY POND DAM
MA 00180**

PHASE I INSPECTION REPORT NATIONAL DAM INSPECTION PROGRAM

DECEMBER 1979

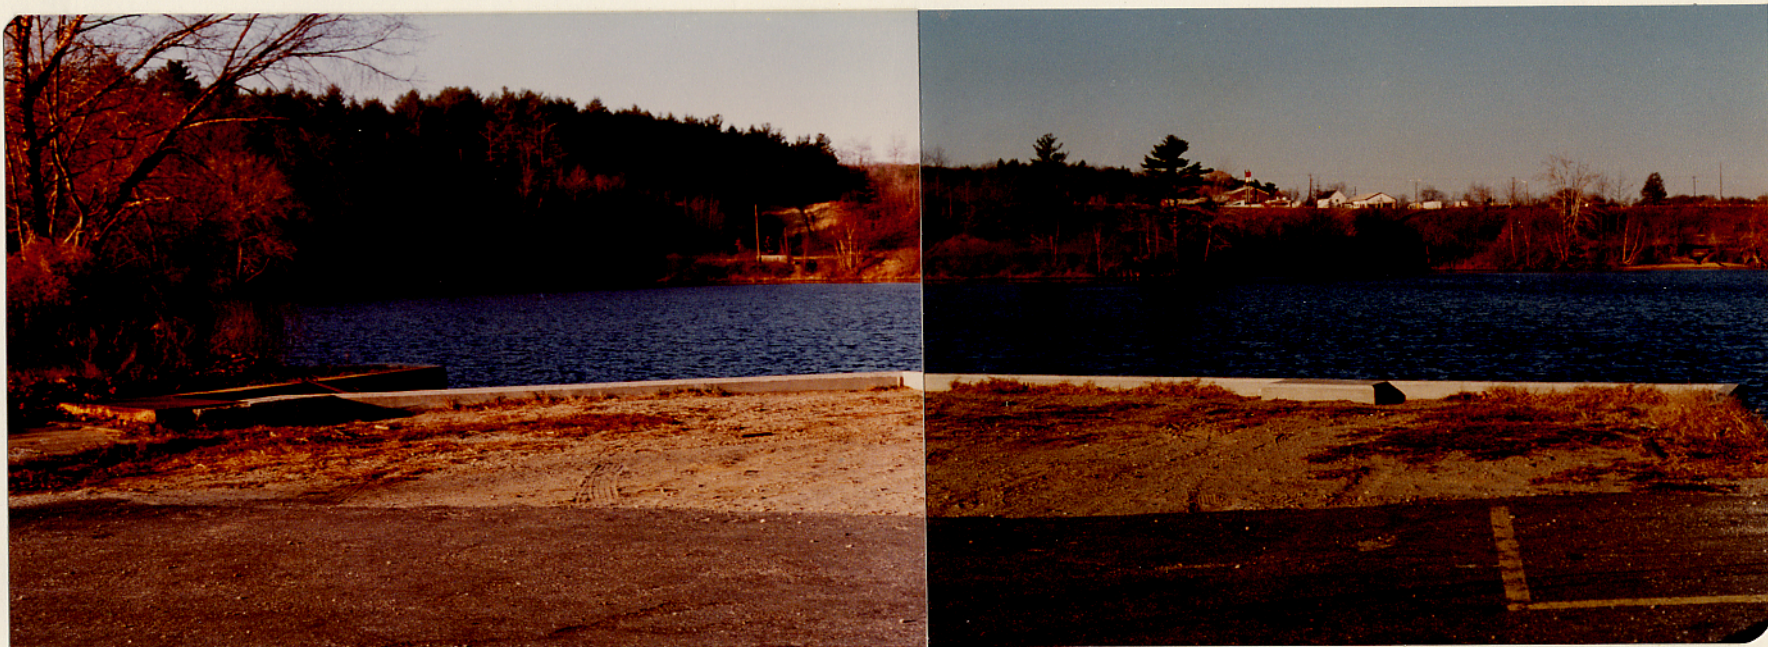
NO. 1 TOP OF DAM AND CONCRETE WALLS

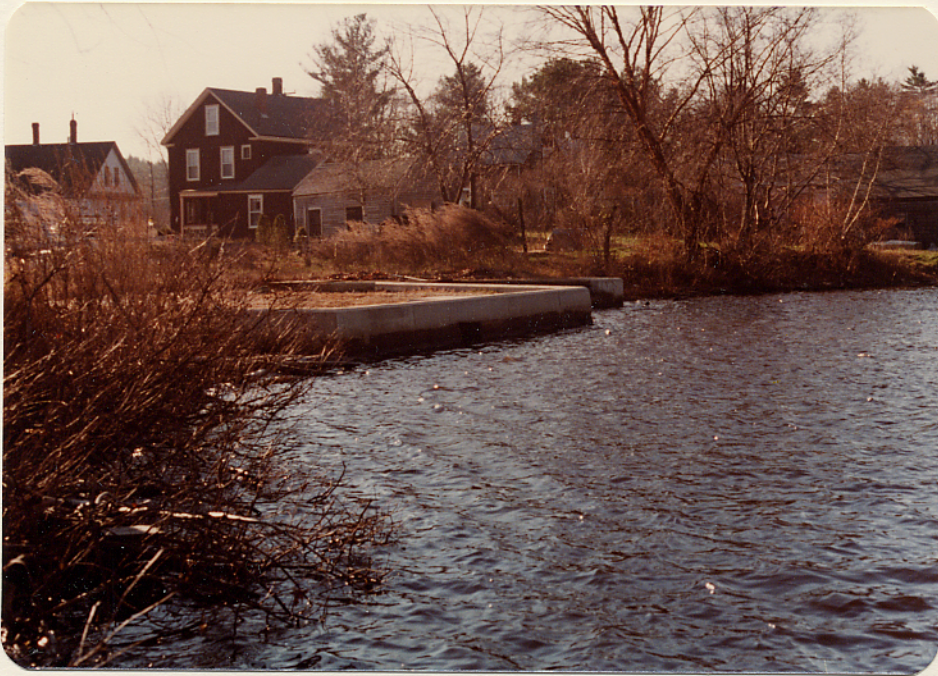
- b. Dam. The dam is an earth embankment with concrete walls along a portion of the upstream face. The top of the dam is earth with some grass. There is no riprap protection on the earth portions of the upstream face of the dam. Riprap is necessary to protect the slopes from erosion. At the north end of the concrete wall, there is a heavily trespassed area about 15 feet wide which is used for launching boats. Most of the area downstream of the dam has been filled in and paved to form a parking lot, which slopes at about 3 percent away from the dam. Minor cracking of the pavement was observed in the vicinity of the discharge conduit, apparently due to settlement of the backfill placed over the conduit. Near the south abutment, the downstream area is also filled in and forms residential property.

NO. 2 UPSTREAM FACE OF DAM

- a. Operating and Maintenance Procedures. It is recommended that the Owner accomplish the following:
 - (1) repair the concrete walls of the dam and spillway,
 - (2) provide slope protection on the earth portions of the upstream face of the dam,
 - (3) continue regular inspection and cleaning of the trash racks upstream of the spillway,
 - (4) implement maintenance inspections of the dam on a monthly basis with additional inspections after storm. Maintenance should include repair of erosion and clearing of vegetation from the embankment. All repairs should be made in accordance with applicable State regulations.
 - (5) conduct technical inspections of the dam and spillway on an annual basis,

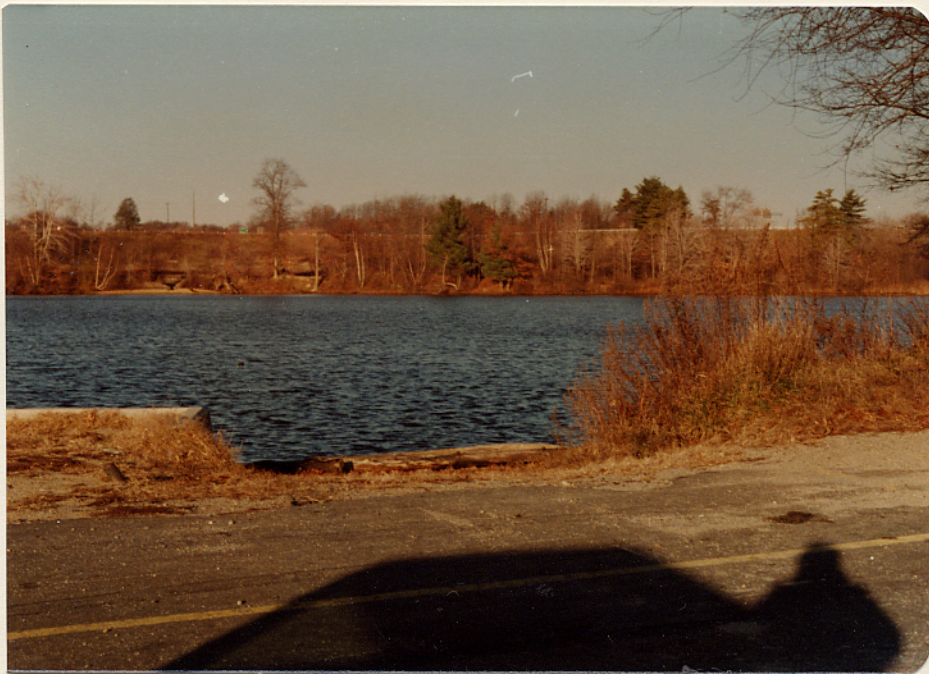
NO. 3 BOAT LAUNCHING AREA AT NORTH END OF DAM

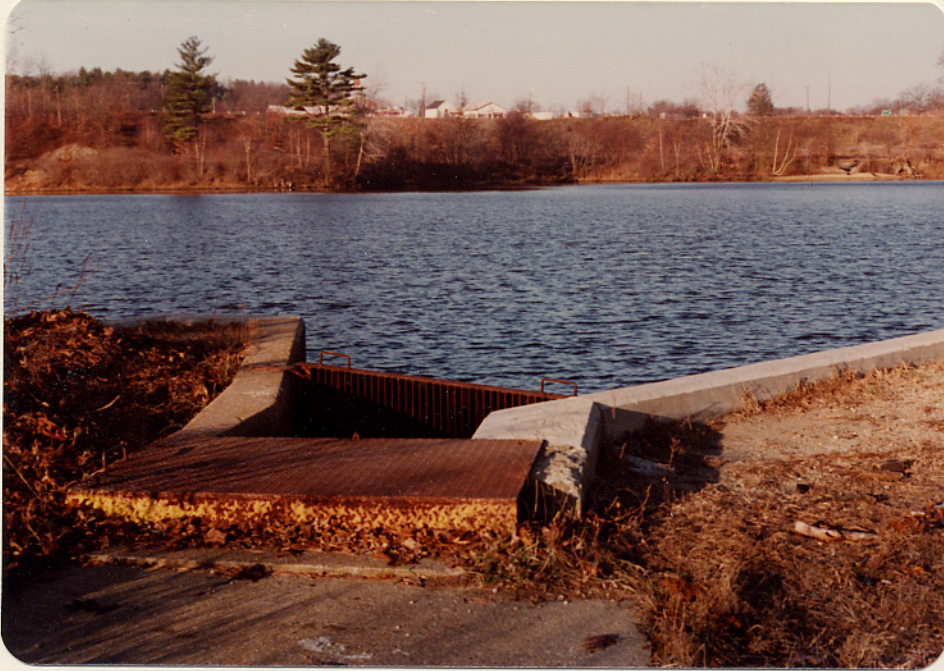
NO. 4 APPROACH CHANNEL OF SPILLWAY WITH STEEL COVER IN PLACE

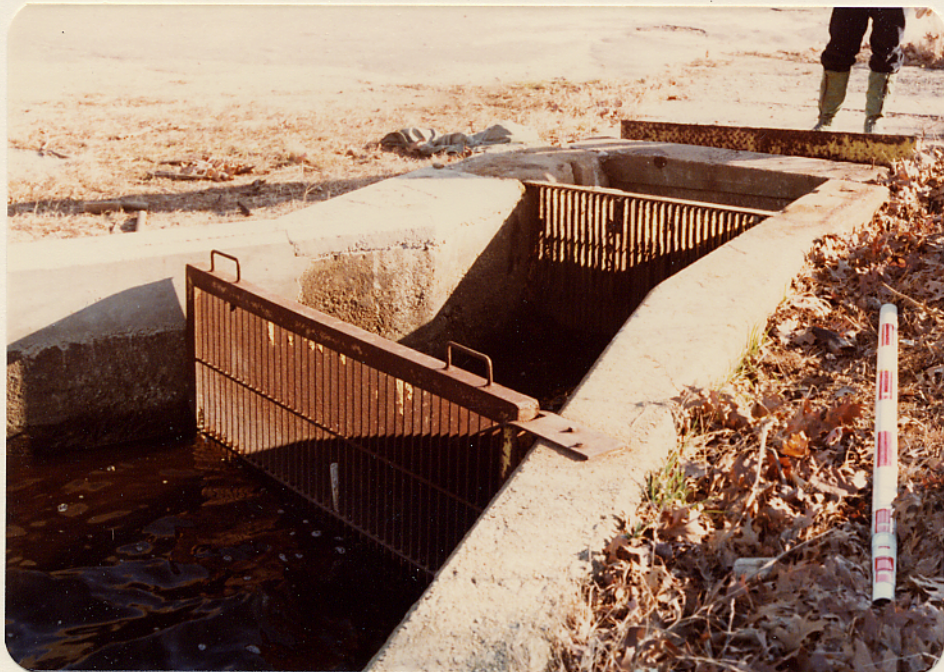
a. Approach Channel	
General Condition	Erosion, cavitation below water level on concrete walls
Loose Rock Overhanging Channel	None
Trees Overhanging Channel	None
Floor of Approach Channel	Gravel upstream of trashracks, concrete downstream of trashracks

NO. 5 APPROACH CHANNEL OF SPILLWAY WITH STEEL COVER REMOVED

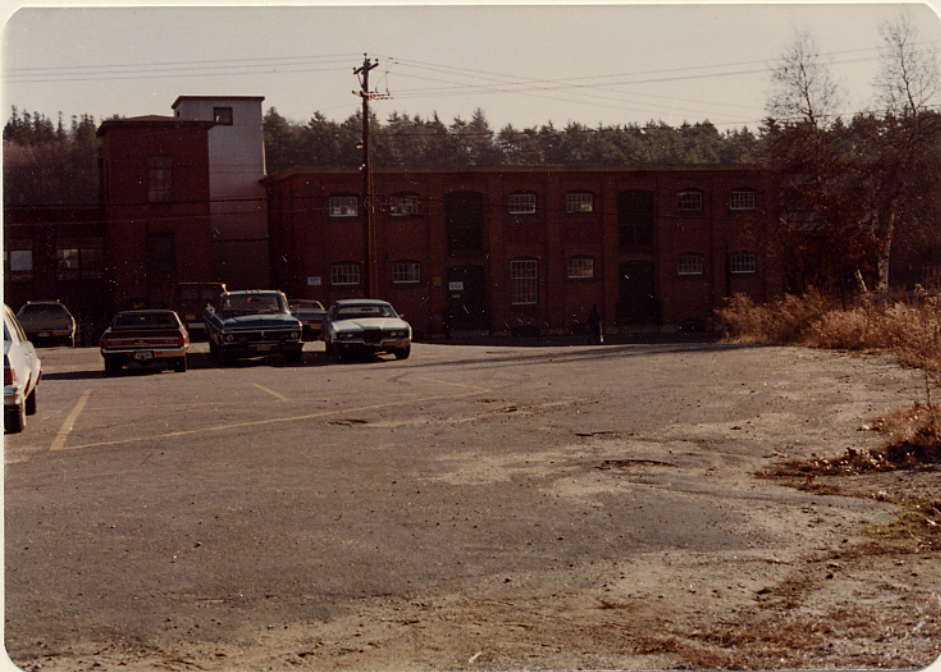
- d. Hazard Classification. Several three-story factory buildings are located about 250 feet downstream of the dam (see overview photo). A paved parking lot for the factory and Merrimack Street are located between the dam and the factory buildings. Failure of the dam is unlikely due to the volume of earth and the flat slope downstream. However, if the dam were to fail, appreciable property damage and loss of a few lives could occur. Accordingly, the dam has been classified in the "significant" hazard category.

NO. 6 PARKING LOT AND FACTORIES DOWNSTREAM OF DAM

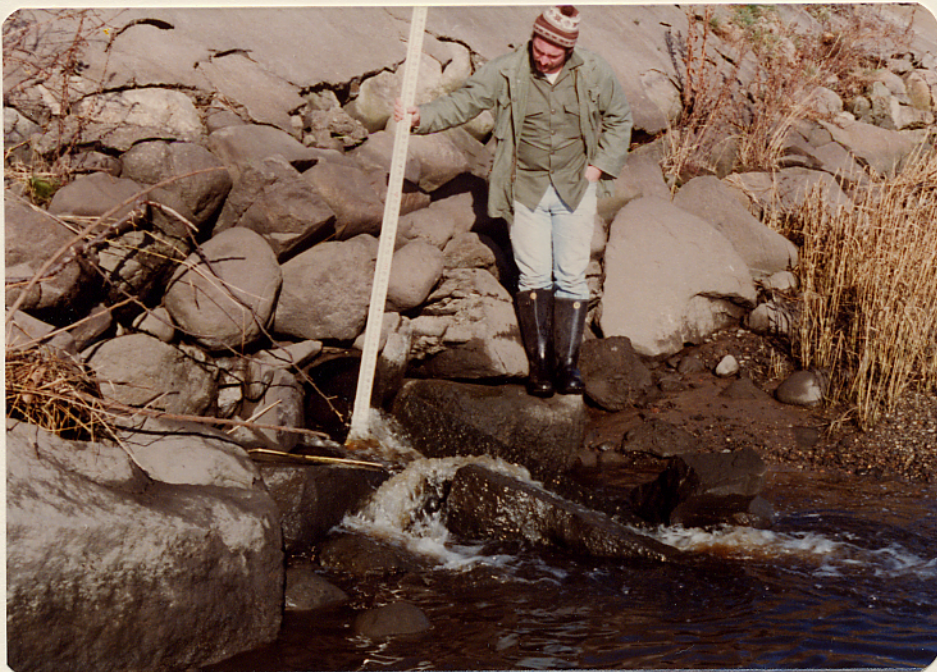
d. Discharge Conduits:	
1. 24-in. concrete pipe at Merrimack Street manhole - conduit flowing freely, no debris in manhole.	
2. 18-in. vitrified clay pipe at Merrimack River - pipe flowing freely, but deteriorating.

NO. 7 18-INCH CONDUIT DISCHARGING INTO MERRIMACK RIVER

- a. evaluate the hydraulic/hydrologic capacity and condition of the spillway and discharge conduits and/or other means of protecting existing structures from damage,
- b. investigate the condition of the vitrified clay pipes downstream of Merrimack Street,
- c. evaluate the need for a low-level outlet or other means for lowering the pond.
